NASA Contractor Report 172371

Flight Service Evaluation of Two Aluminum-Brazed Titanium Spoilers

R. R. Boyer

**Boeing Commercial Airplane Company
Seattle, Washington**

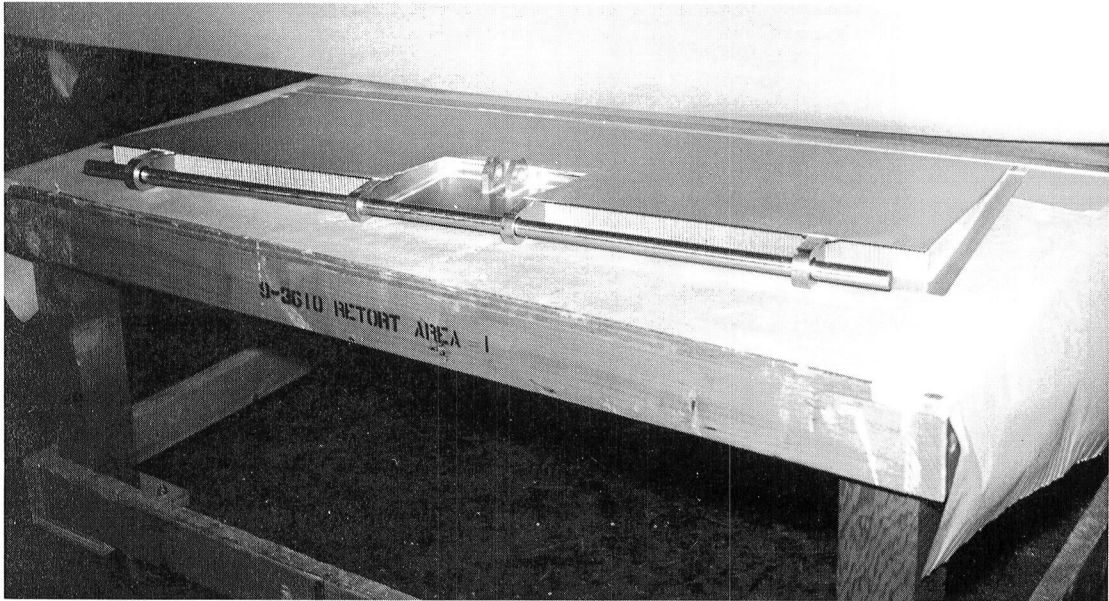
Figure 5. Brazed Flight Spoiler—S/N 002

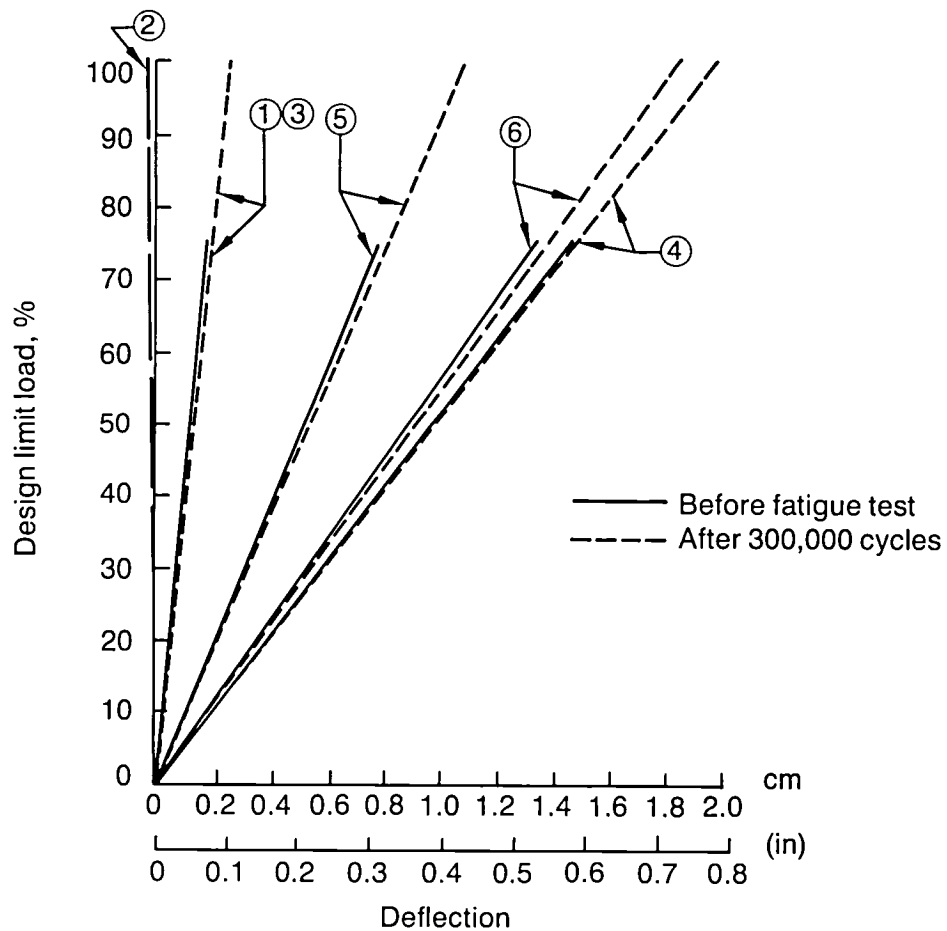
No evidence of any problem was detected in the spoiler, visually or through the strain gages, during the fatigue testing. However, two cracks were detected in the upper skin after the load pads were removed for inspection. Failure analysis revealed that the fatigue cracks initiated at about 175,000 cycles. The loading pads were reinstalled and the spoiler was again statically loaded, this time to 100% design limit load; tip deflections were the same as for the original static loading (Fig. 7). A more detailed description of the testing is contained in reference 6.

Figure 7. Flight Spoiler Deflection

The skin cracks that formed during the fatigue testing initiated at sharp corners at the aft end of the center yoke. These corners were rounded off for future design to reduce the stress concentration in this area, a change that was incorporated in spoiler S/N 003.

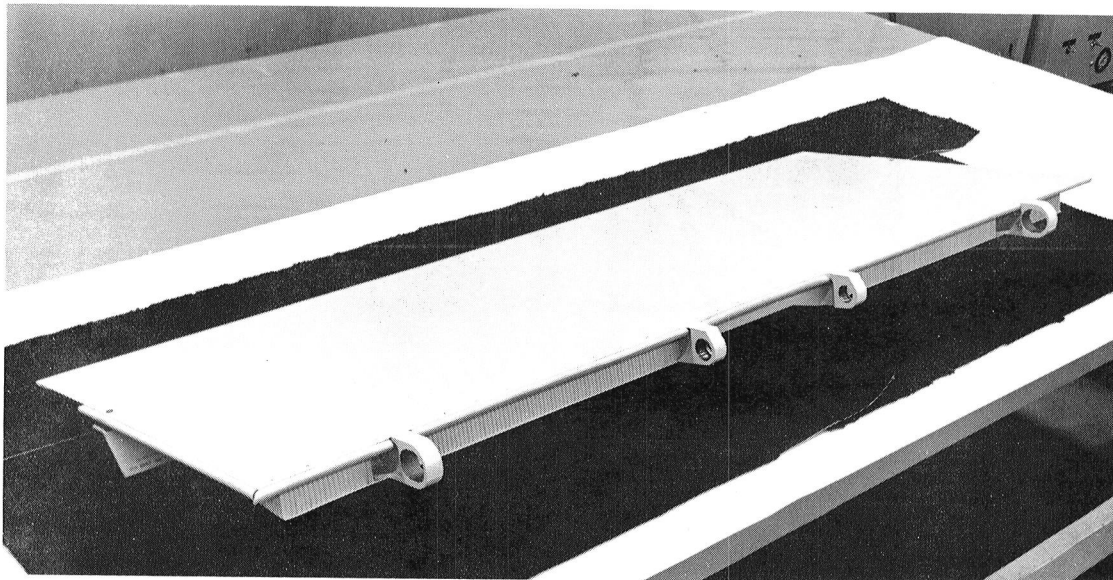
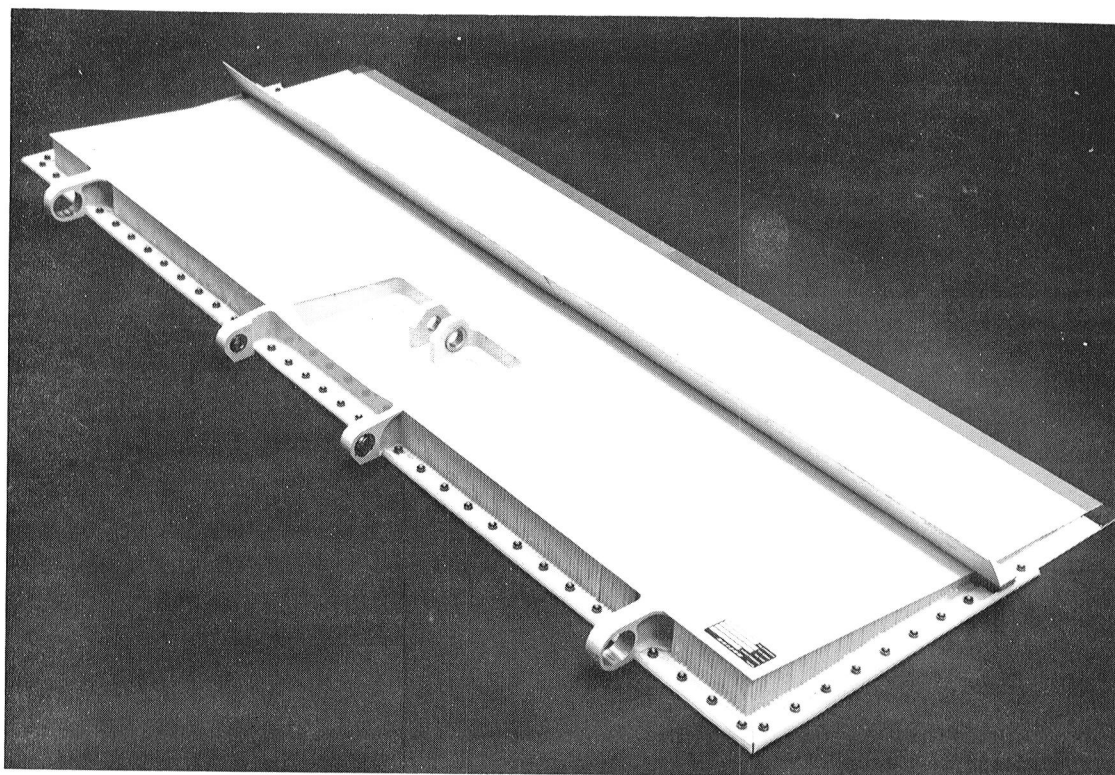
(a) Upper surface

(b) Lower surface

Figure 8. Completed Flight Spoiler

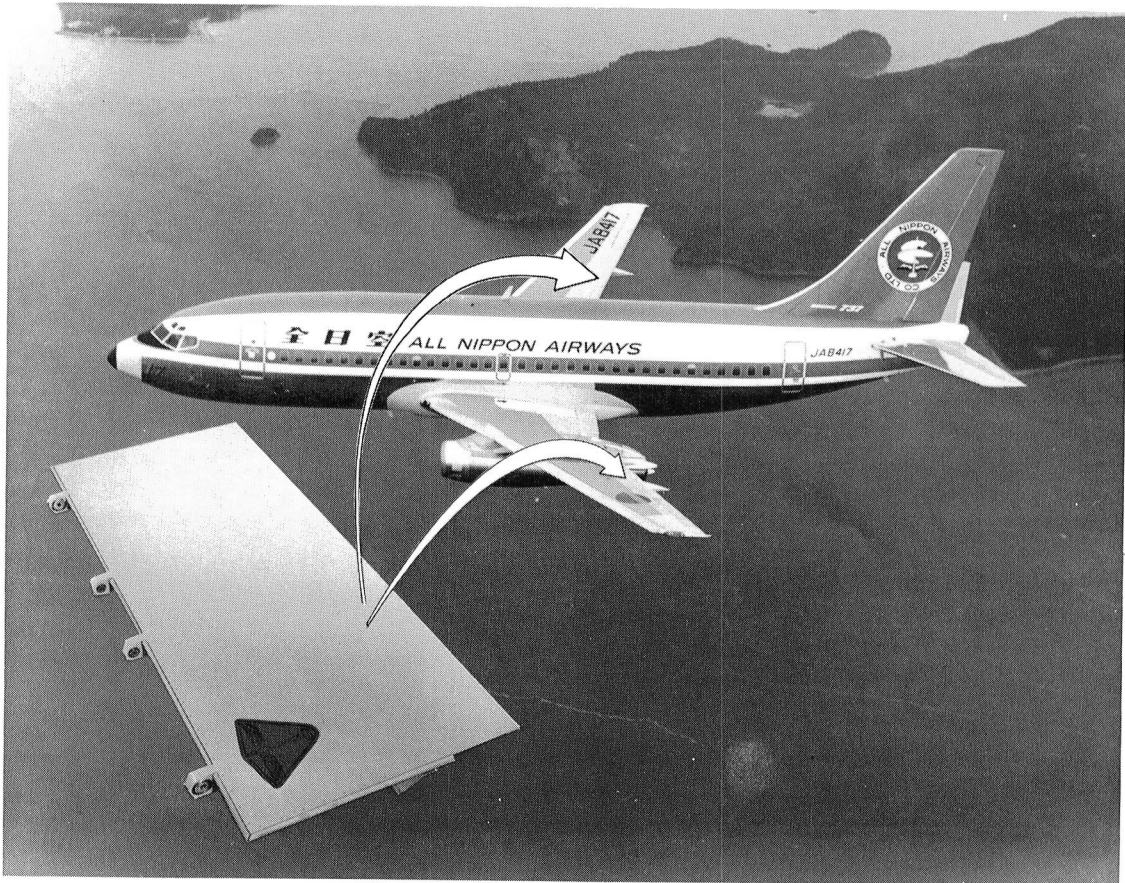
The spoilers were flown on three different aircraft. Since they were removed and reinstalled at different times, the two spoilers had slightly different numbers of flight hours and flight cycles. Spoiler S/N 002 was initially installed on April 2, 1974 and spoiler S/N 003 on September 9, 1974. Spoiler S/N 002 was always deployed at the inboard position of the right wing and spoiler S/N 003 at the outboard position of the left wing (Fig. 9). The total service experience for the two spoilers is indicated below:

Figure 9. Location of Flight Spoilers on All Nippon Airways Model 737

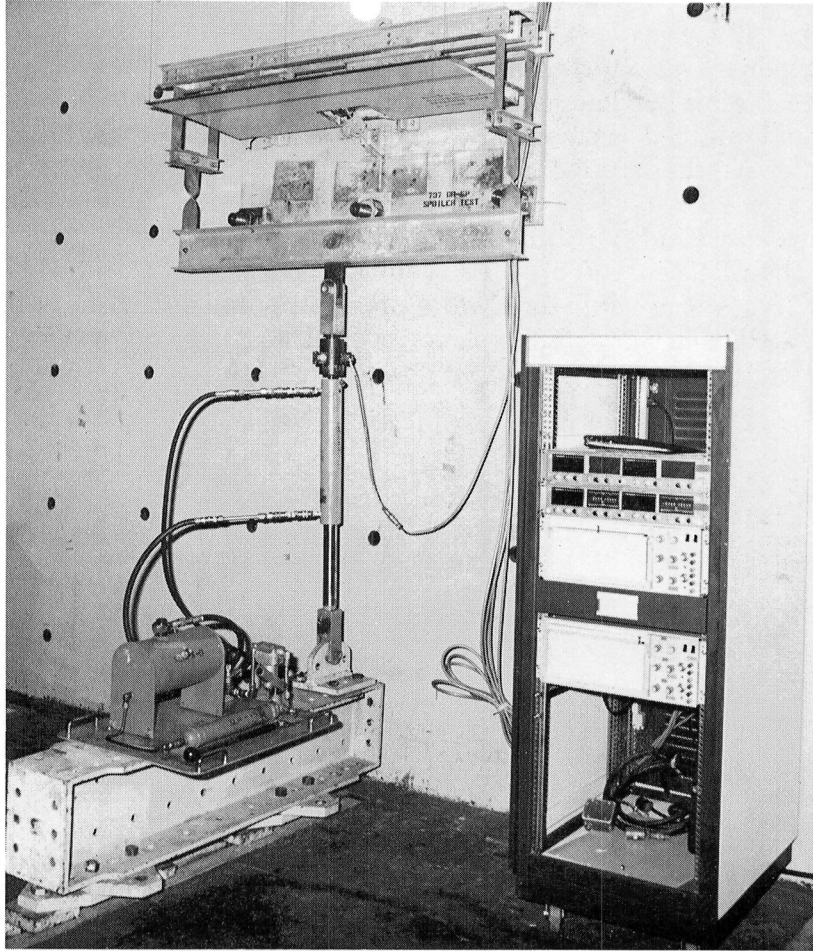
The final, and possibly most significant, means of verifying the structural durability of the spoilers was by comparing spoiler deflections upon imposition of design limit load before and after flight service. The spoilers were mounted to a strongback at the hinge points. Simulated air pressure was applied to the upper surface of the spoiler with eight rubber pads and an evener linkage system by two hydraulic actuators used to apply loads in both directions. The test setup used, shown in Figure 28, was the same as that used in the initial testing. The design limit load distribution of the spoilers was illustrated in Figure 6. The locations of the load pads and the three EDIs are shown in Figure 29. The load and EDI readings were recorded at 15% increments through 90% design limit load, then at 100% design limit load, 1720 kg (3792 lb). This was done twice for each spoiler. Neither spoiler took on a permanent set as a result of these tests.

Figure 28. Test Setup for Applying Simulated Design Limits Loads to Flight Spoilers

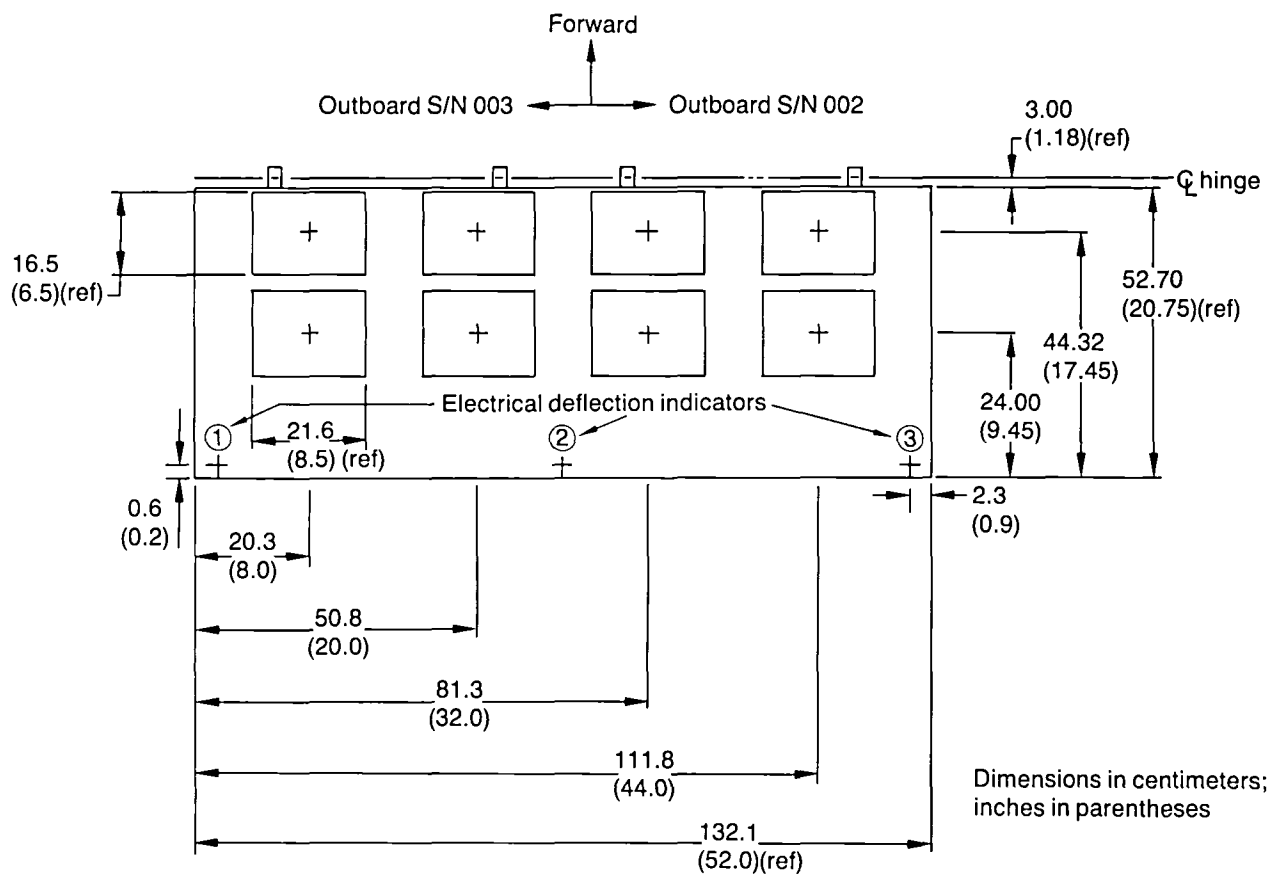
Figure 29. Location of Load Pads and Electrical Deflection Indicators Used for Design Limit Load Tests
